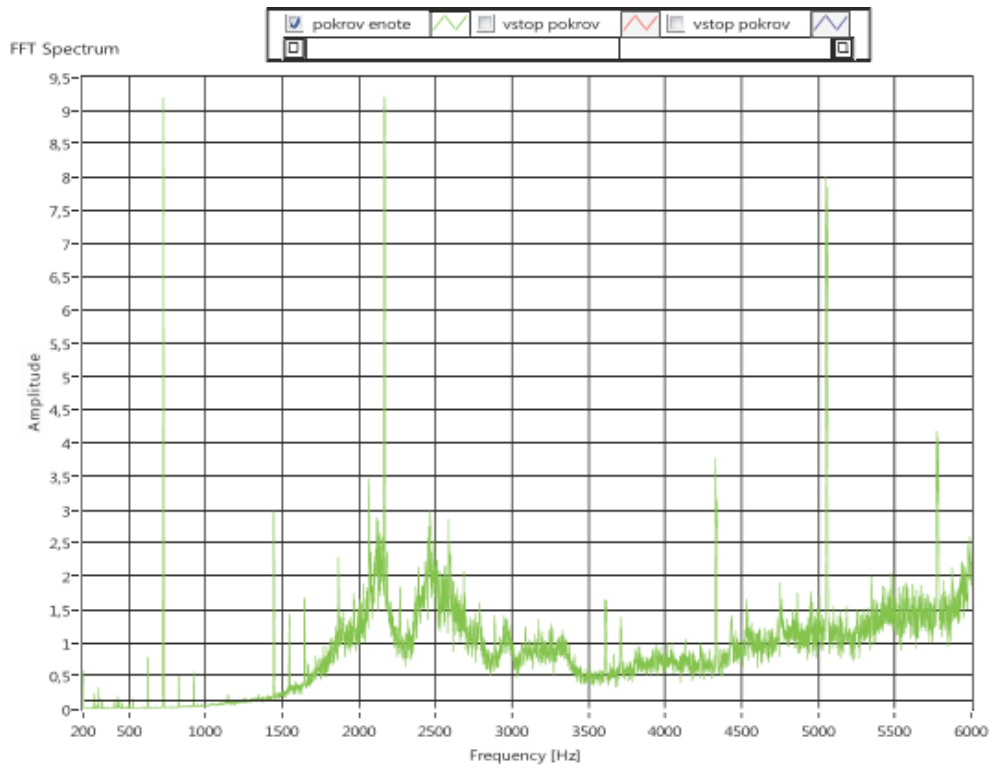
Slika 7.1: Amplitudna analiza vibracij na vstopu s togim pokrovom- mikrofoni 2
